THERMOGRAPHIC STUDIES AND SERVICES FOR FACILITIES, SYSTEMS, AND ENERGY PERFORMANCE EVALUATIONS

INFRARED IN ACTION

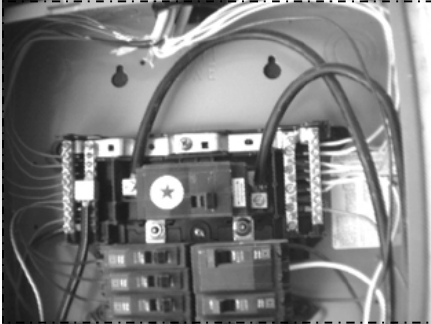
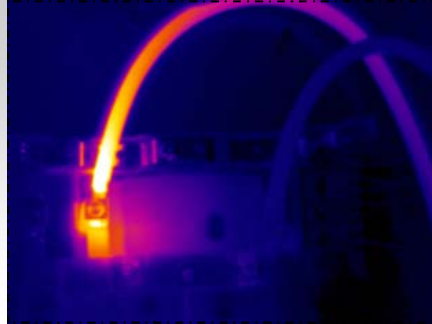
Locate electrical problems with infrared. In the example shown here, circuit breaker phase exceeds 80% ampacity, and the temperature exceeds breaker rating. Aside from not adequately meeting power needs, this issue poses a potential electrical fire hazard

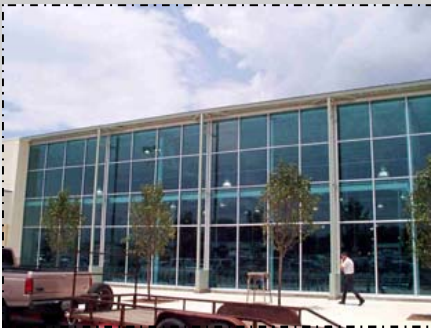
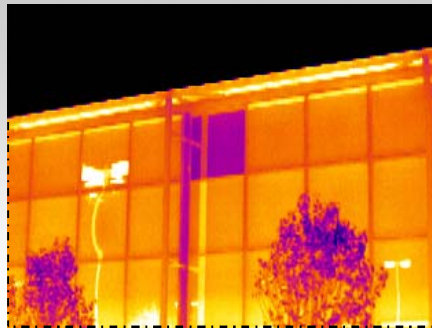
This thermal image clearly demonstrates the energy efficiency difference between single and double pane windows with the darker window showing significant energy loss in this summer time thermal image. Infrared offers the best technology to quickly and accurately locate areas of energy inefficiency - enabling cost savings for your home or business as well as better use of limited energy resources.

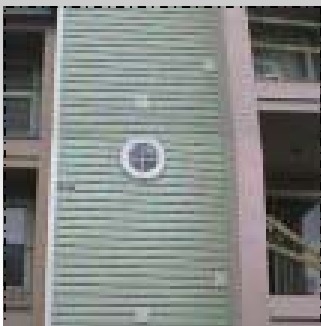
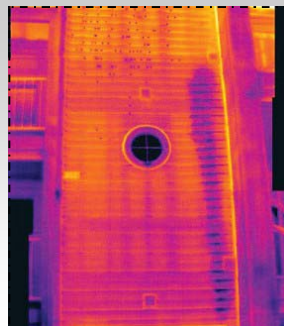
The thermogram of this vinyl-sided 3-floor apartment house clearly shows the path of a serious water leak - completely hidden within the wall - from a washing machine on the third floor. The thermographer used FLIR's Image Builder software to automatically "stitch" the three individual thermographs into one fully thermographic collage.

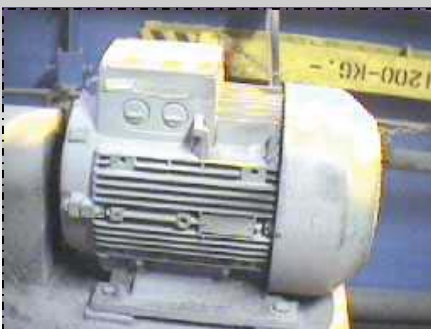
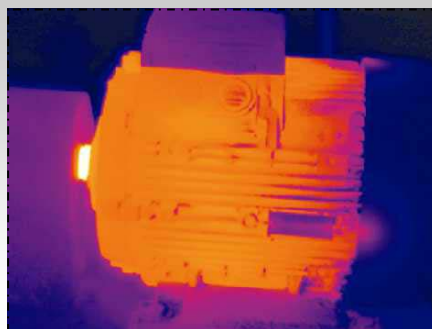
This motor has an internal winding problem, detected by the infrared camera, but otherwise not visible.
